A Performance and Systems Audit of The Acidic Precipitation in Ontario Study Monitoring Networks

ARB-69-83-ARSP

Ministry of the Environment Air Resources Branch 880 Bay Street, 4th Floor Toronto, Ontario

Concord Scientific Corporation 2 Tippett Road Downsview, Ontario

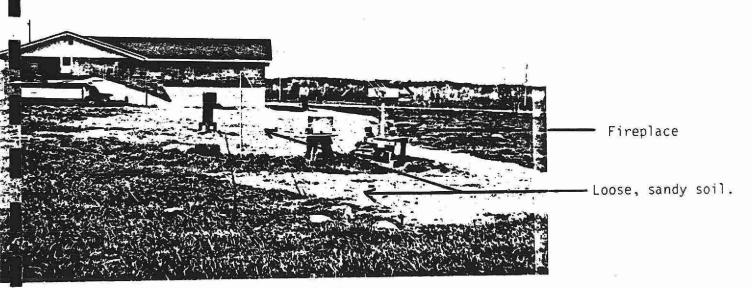
Figure 2: Mattawa Cumulative Sampling Site

The cumulative monitoring site at Mattawa (Figure 2) was judged to be unacceptable due to the poor ground cover (loose sandy soil) at the site, and the fact that the operator regularly incinerated garbage at a small fireplace near the low volume air sampler. The operator stated that he occasionally covers the precipitation sampler at these times, but does nothing to protect the air sampler.

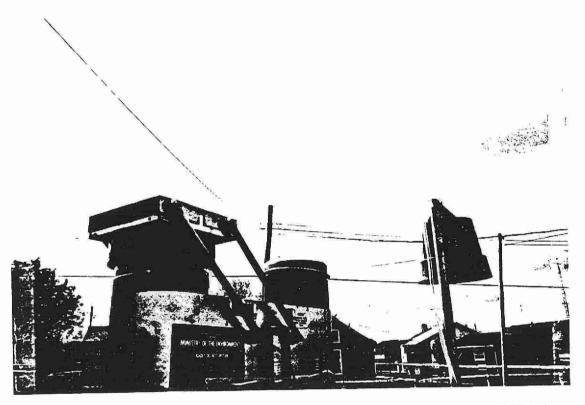
Figure 7: Typical North Western Region Low Vol Sampler Installation

Some additional problems that were noted with respect to the Sangamo/MIC collector configuration were a result of the installation of supplementary equipment at the site. One particular problem was the installation of the air sampling sampler filter heads at some of the At these sites the filter pack and Northwestern Region sites. (weatherproof cover) assemblies for the air samplers were installed on the sampling platform about 40 cm from the dry side bucket (Figure 7). This results in potential interference to the Sangamo sampling by the air sampler since the Sangamo sample container is in the shadow of the low vol hood. The air sampler instrument boxes were also often placed on the Sangamo sampling platform which reduced the space available on the stand and often hindered the operator during sample changes. Consideration should be given to constructing separate support stands and shelters for the low vol sampler equipment to avoid interference with the precipitation samplers.

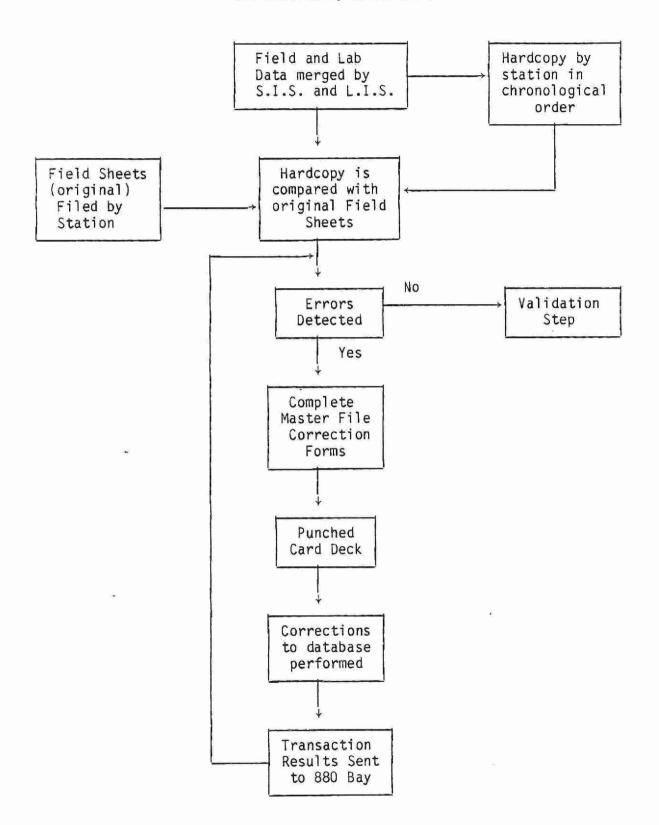
Figure 11 Schematic For Merging and Editing Field and Laboratory APIOS Data

The data entry editing and validation procedures for the laboratory and central office of the programme are illustrated in Figures 11 and 12.

As the samples are received at the lab, they are automatically queued into the Laboratory Information System (LIS) and data base and then routed to the appropriate work stations within the laboratory. Once the analyses are completed, the data are dumped into the SIS data system by the LIS system for merging with the field data (Figure 11). Once the laboratory analysis is completed, the field sheets are keypunched and submitted for inclusion in the SIS data base.

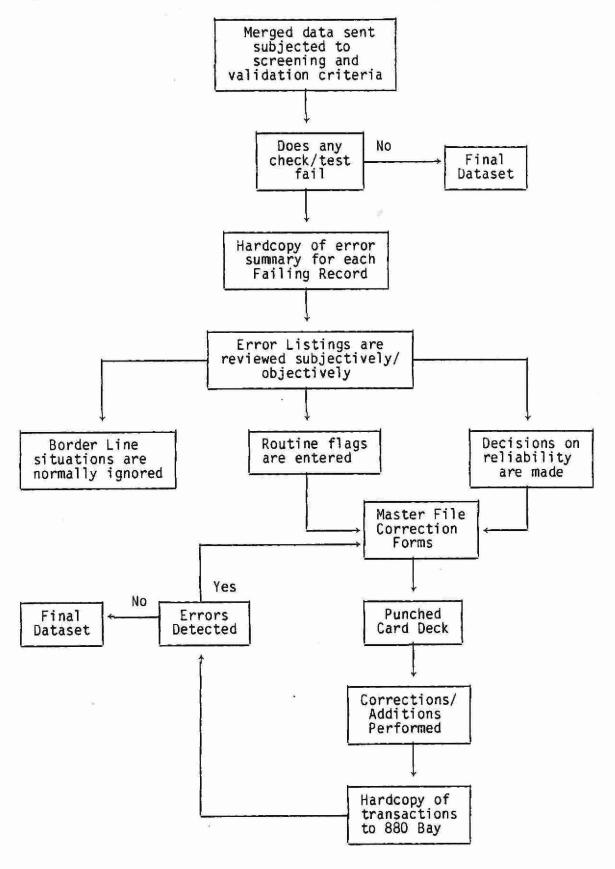
Figure 12 APIOS Data Validation Procedures Algorithm

Data validation procedures have been implemented for the event precipitation monitoring results. These procedures are used to automatically screen the data collected according to a set of predetermined criteria. The basic algorithm (Figure 12) that has been used to perform these validation steps will be used for the data from all of the APIOS monitoring networks. Only the details of the specific checks and screening procedures will have to change.

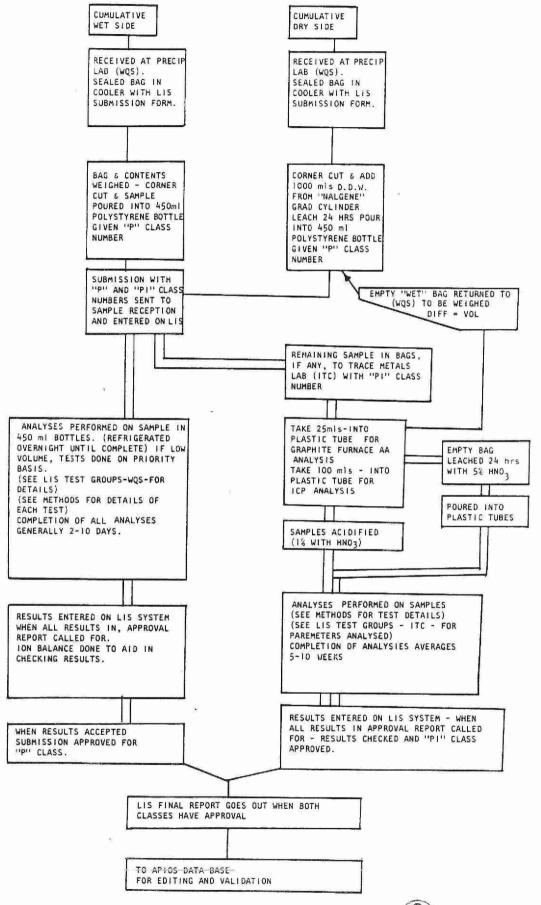
Figure 19 Laboratory Samples Handling Procedures - Cumulative Precipitation Samples

The systems audit consisted of a review and evaluation of the sample handling, analysis and data entry procedures for the laboratory system. The handling and analysis procedure, for the various types of samples are presented in Figures 19 to 21 and are summarized briefly below.
